DENILIQVIN COUNCIL

EDWARD RIVER AT DENILIQVIN FLOOD STUDY

EDWARD RIVER AT DENILQUIN FLOOD STUDY

FINAL REPORT

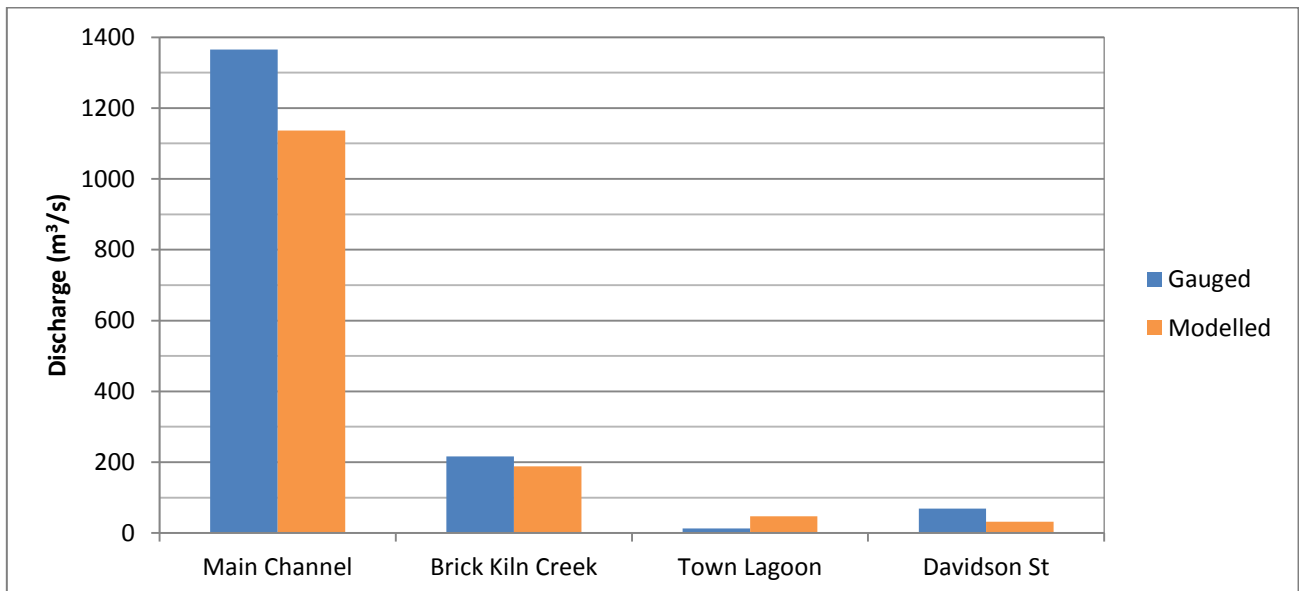
Figure 2 1931 Peak Flow Distribution - Gauged and Modelled

The discrepancy between modelled and gauged flows lead to considering what possible floodplain features were not being incorporated in the model. Changes were made to the model that could potentially cause an increase of 270 m³/s at a depth of 9 m (the discrepancy in Figure 1). This investigation was aided by the components that were gauged in 1931 as comprising separate flowpaths, as recorded on the gauging cards. Specifically, the total flow was made up of four components: the main channel, Brick Kiln Creek, over Davidson St, and the lagoon through the town. The flow distribution through these components is shown in Figure 2.

As can be seen in Figure 2, the 270 m³/s discrepancy is almost solely contained in the difference between the gauged and modelled discharge in the main channel (it should be noted that the flow over Davidson St was not gauged, but rather estimated by an unspecified method that did not involve measuring velocity or

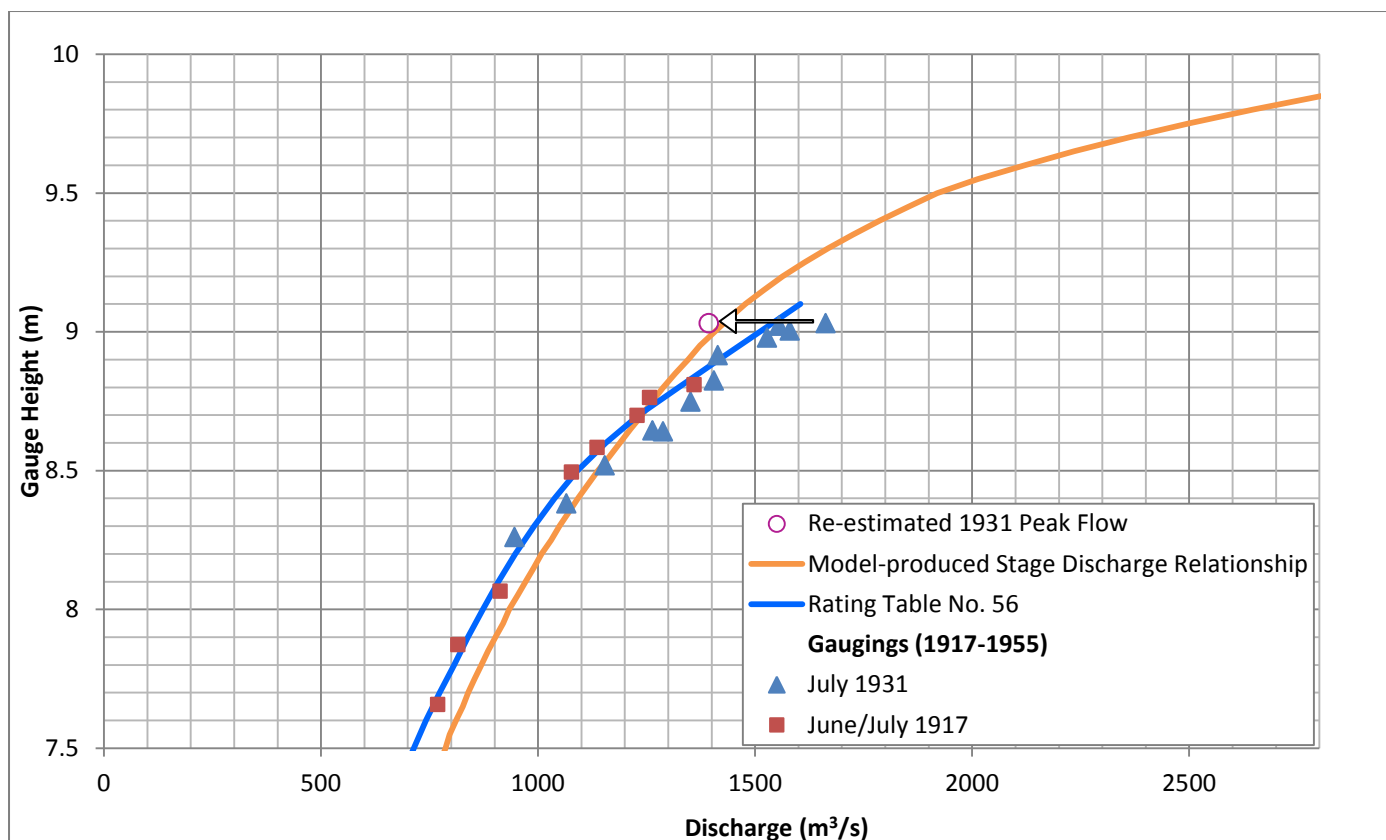
Figure 6 Gaugings and Rating Tables with Re-estimated 1931 Peak Flow Gauging

Given that these four intervals contain around 60% of the total flow (including that in Brick Kiln Creek, over Davidson Street and through the town), it is apparent that the error in the total flow may be significant, at approximately 10-15%. Reducing the estimated flow by this amount results in the peak flow decreasing by around 250 m³/s, which brings it in line with the stage-discharge relationship estimated by the 2D hydraulic model at this level. The re-estimated gauging is shown in Figure 6.
