# EDWARD RIVER AT DENILIKUIN FLOODPLAIN RISK MANAGEMENT STUDY AND PLAN

## FINAL REPORT

<b>Project</b> Deniliquin Floodplain Risk Management Study and Plan		<b>Project Number</b> 115027	
<b>Client</b> Edward River Council		<b>Client's Representative</b> Julie Rogers	
<b>Authors</b> Felix Taaffe Catherine Goonan		<b>Prepared by</b>

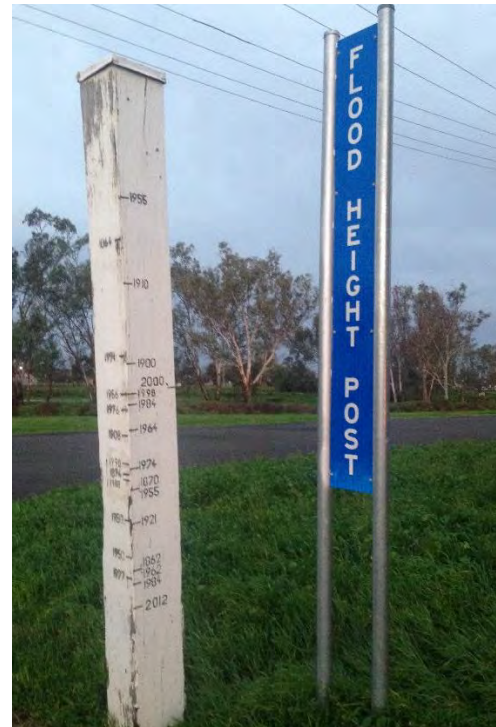
Photo 3 Flood Height Post, Gunnedah, NSW (Photo C. Burgess 2016)

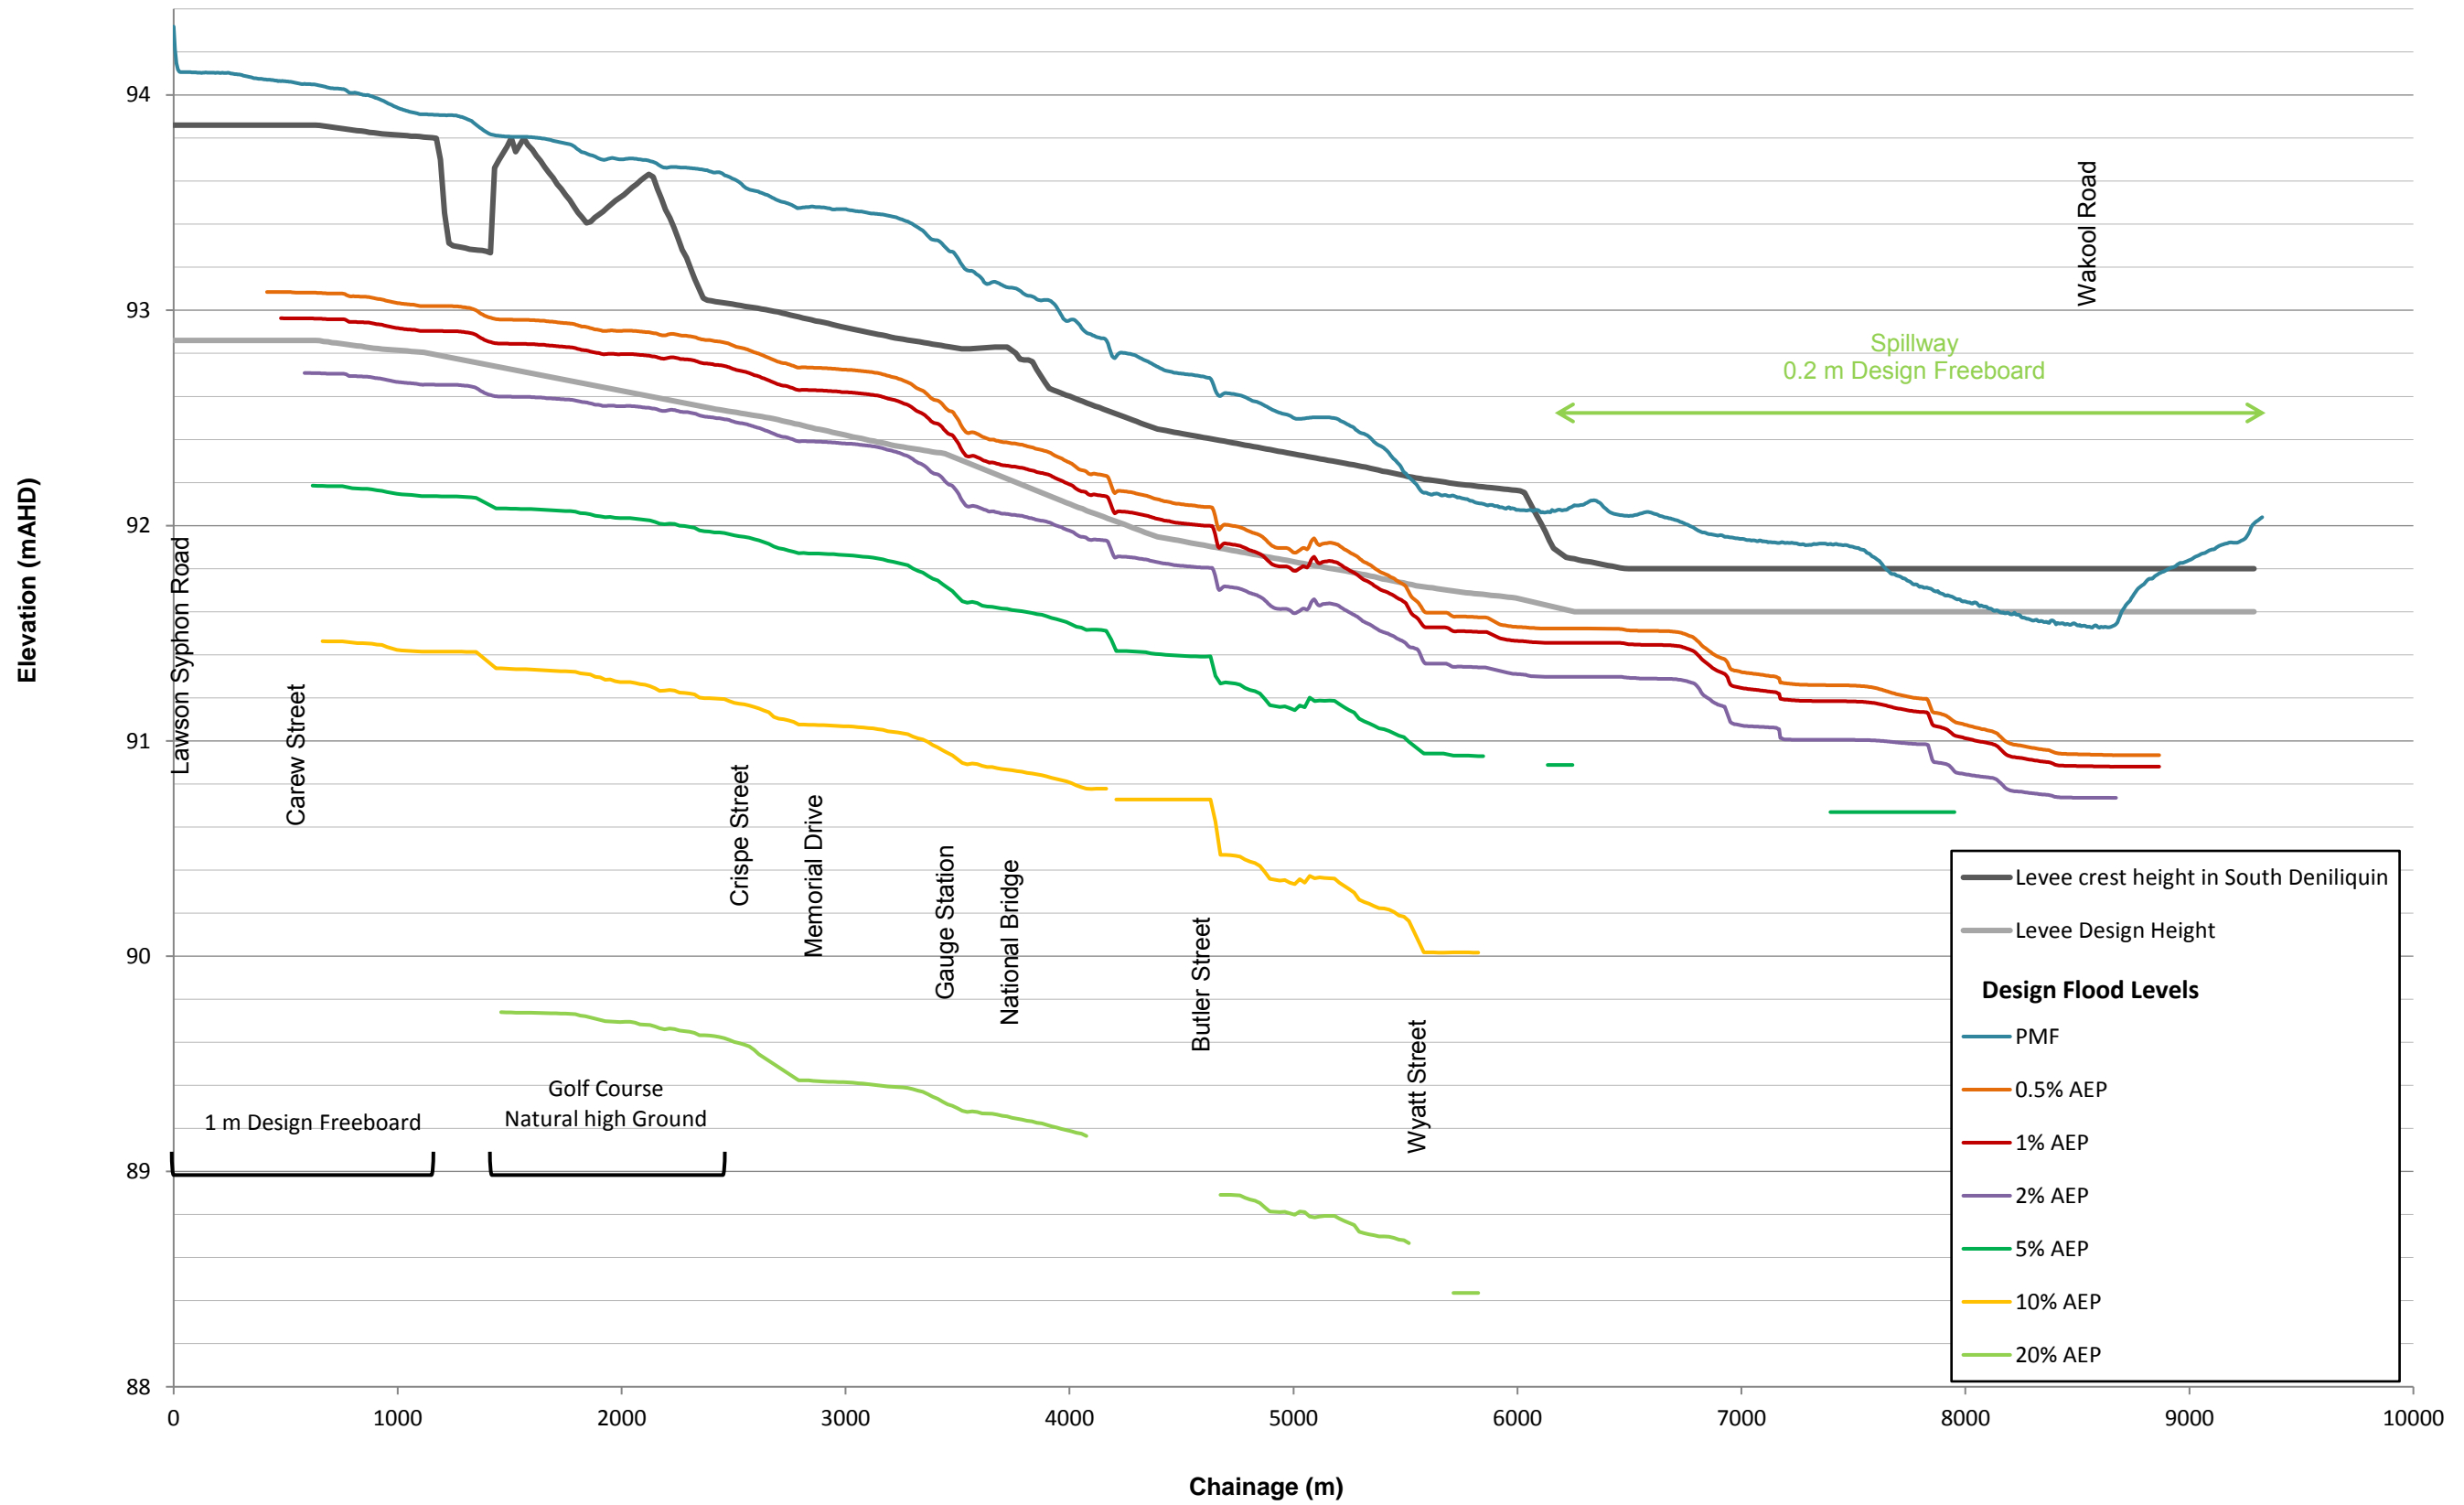
FIGURE 11  
SOUTH DENILIQUIN LEVEE  
DESIGN FLOOD EVENT PROFILE

NOTE: The remainder of the levee has a 0.5 m design freeboard.

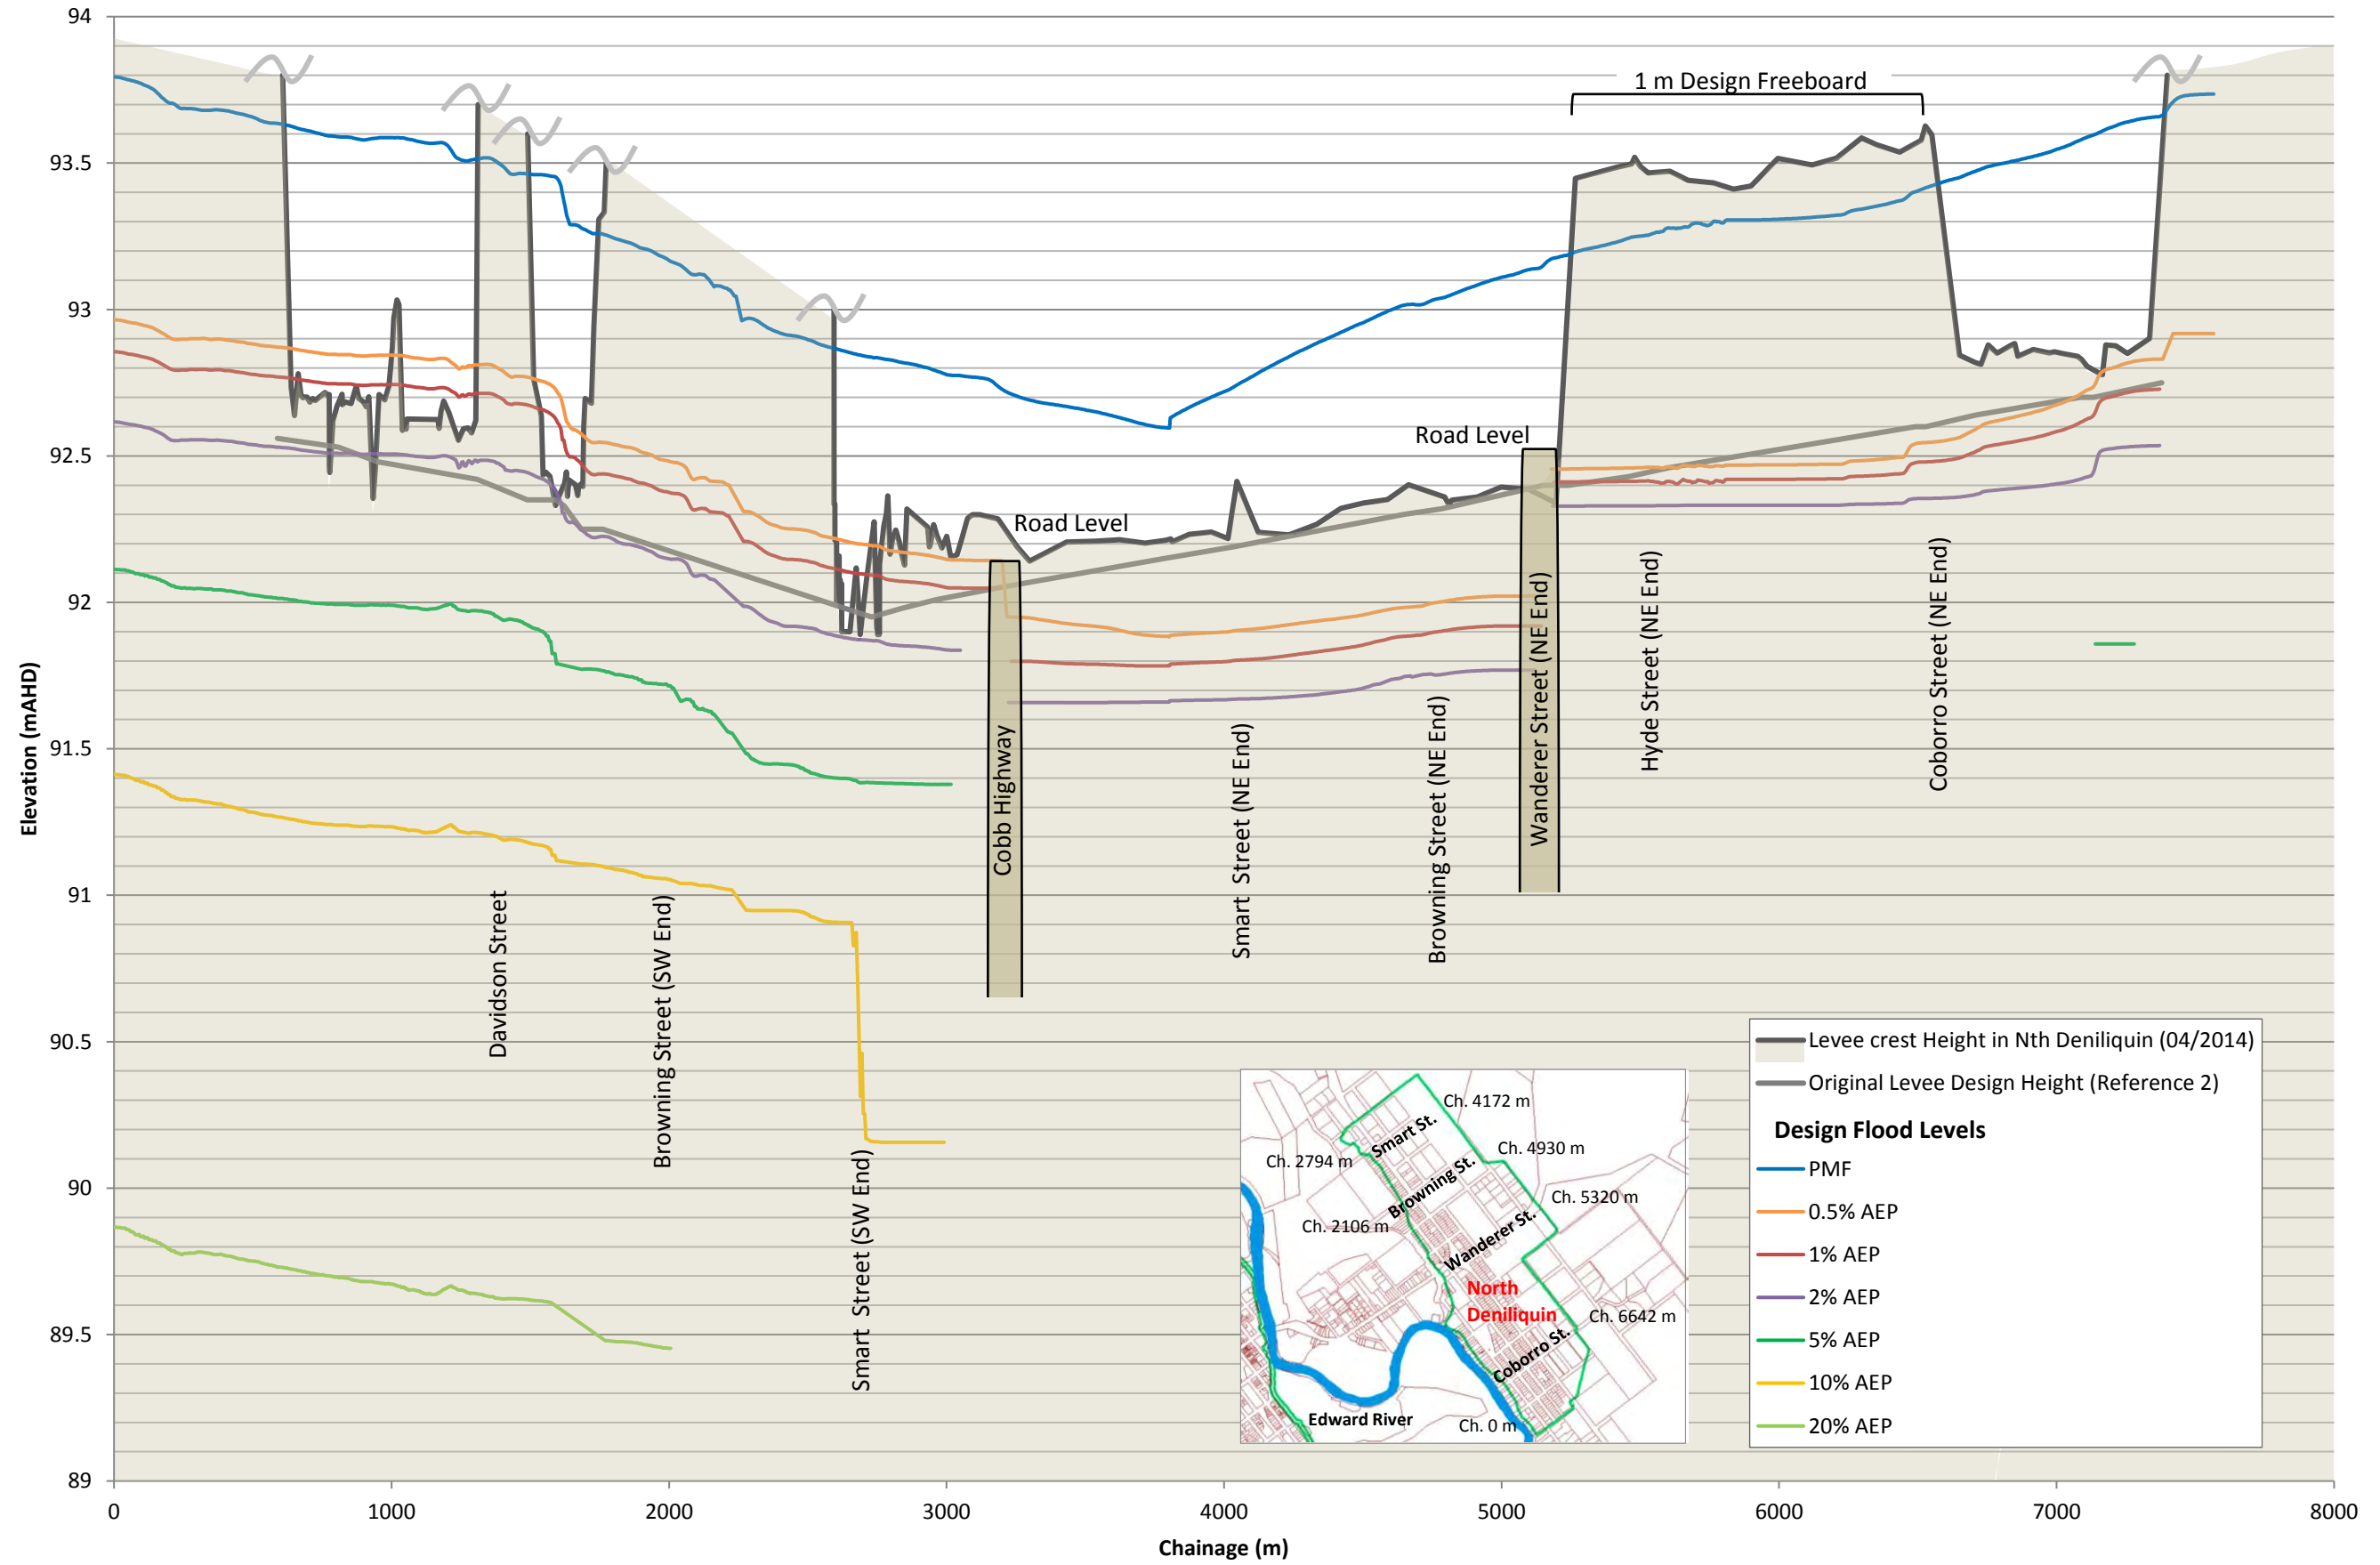
FIGURE 12  
 NORTH DENILIQUN LEVEE  
 DESIGN FLOOD EVENT PROFILE

NOTE: - Levee elevations above 94 mAHD are sections of natural high ground in North Deniliquin that form part of the levee structure.  
 - All other sections of the levee have a design freeboard of 0.1 m, except where shown above between chainages 5200 m and 6500 m.

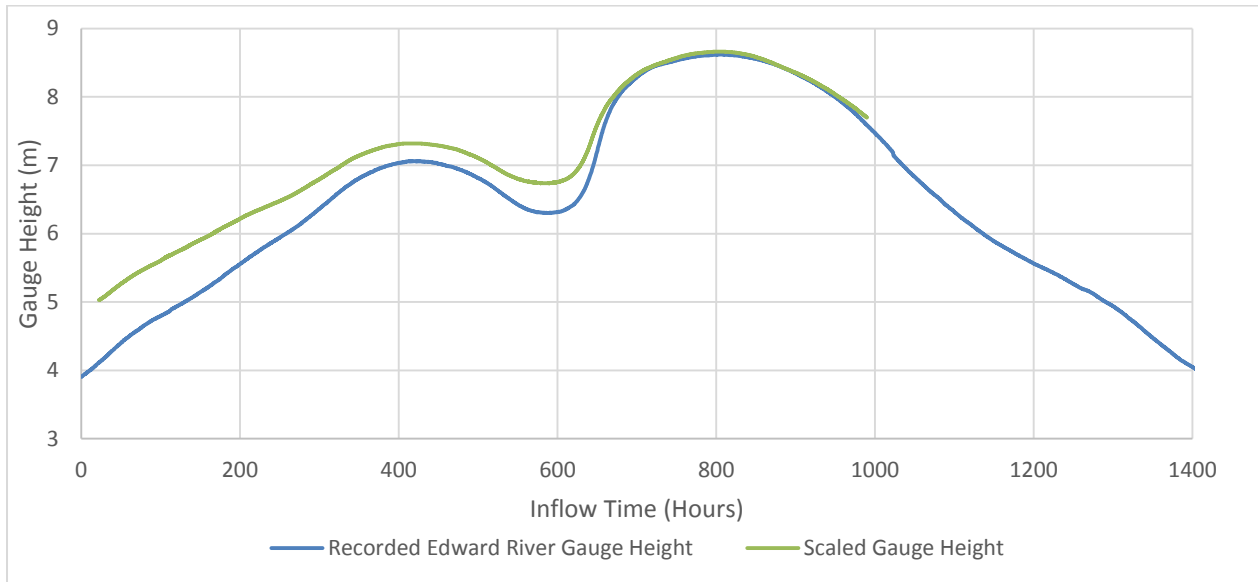
Chart 6: Final Edward River Gauge Level Comparison

It is noted that there is a single location just downstream of the town where the modelled flood level is not within +/- 150 mm of the recorded level. However, the point is in close proximity to points with accepted tolerances. Recorded flood levels that are not within the extent of the modelled 2016 event are considered to be areas that are affected by localised or overland flow flooding as a result of intense local rainfalls (and are denoted as null with a value of '-999').

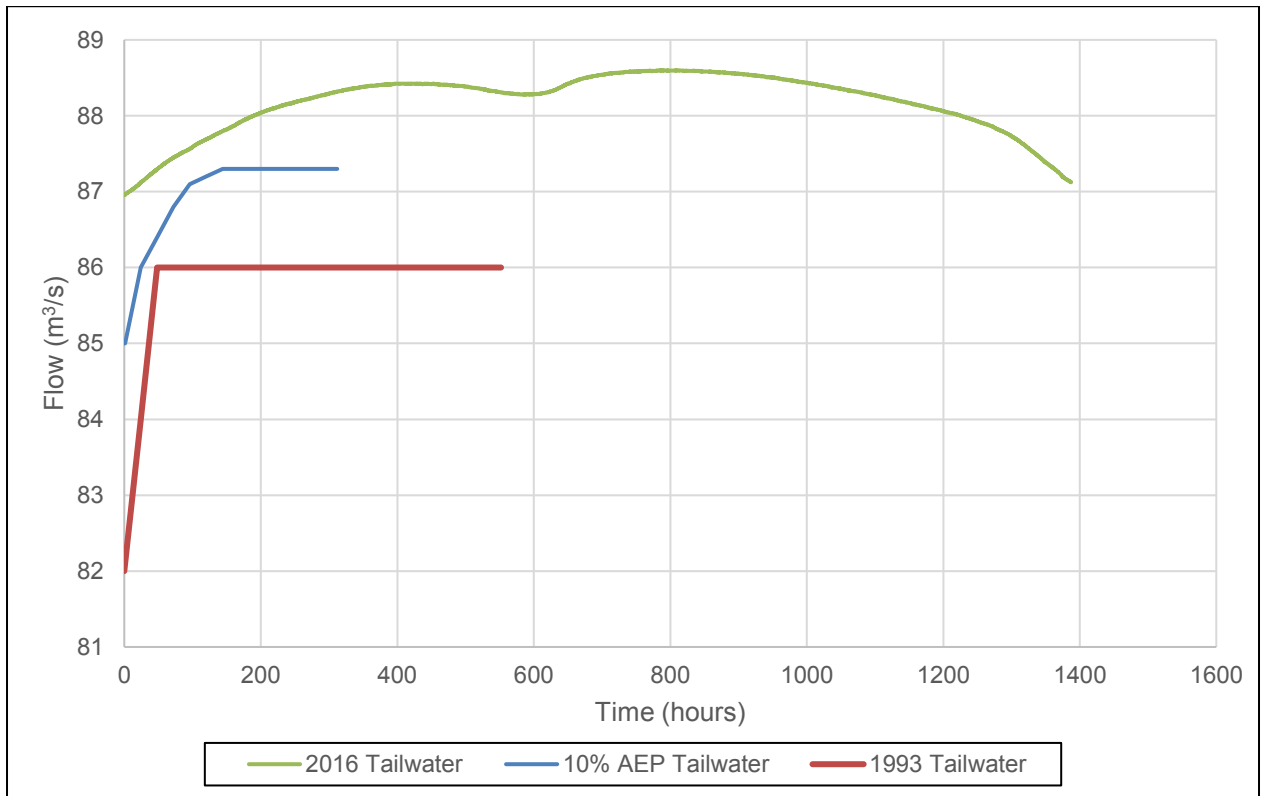
Chart 8: Model Tailwater Comparison

The modelled tailwater conditions for the 2016 event are significantly higher than those utilised in the other models with a peak value 1 m higher than the 10% AEP event and over 2 m higher than the 1993 event as can be seen in Chart 8. The higher tailwater allows a significant amount of water to remain in the flood model particularly in the downstream end of the catchment, contributing to the difference in flood levels and extent. The combination of recorded extent information and comprehensive flood levels across the study area has allowed a more accurate estimate of the 2016 event tailwater conditions.

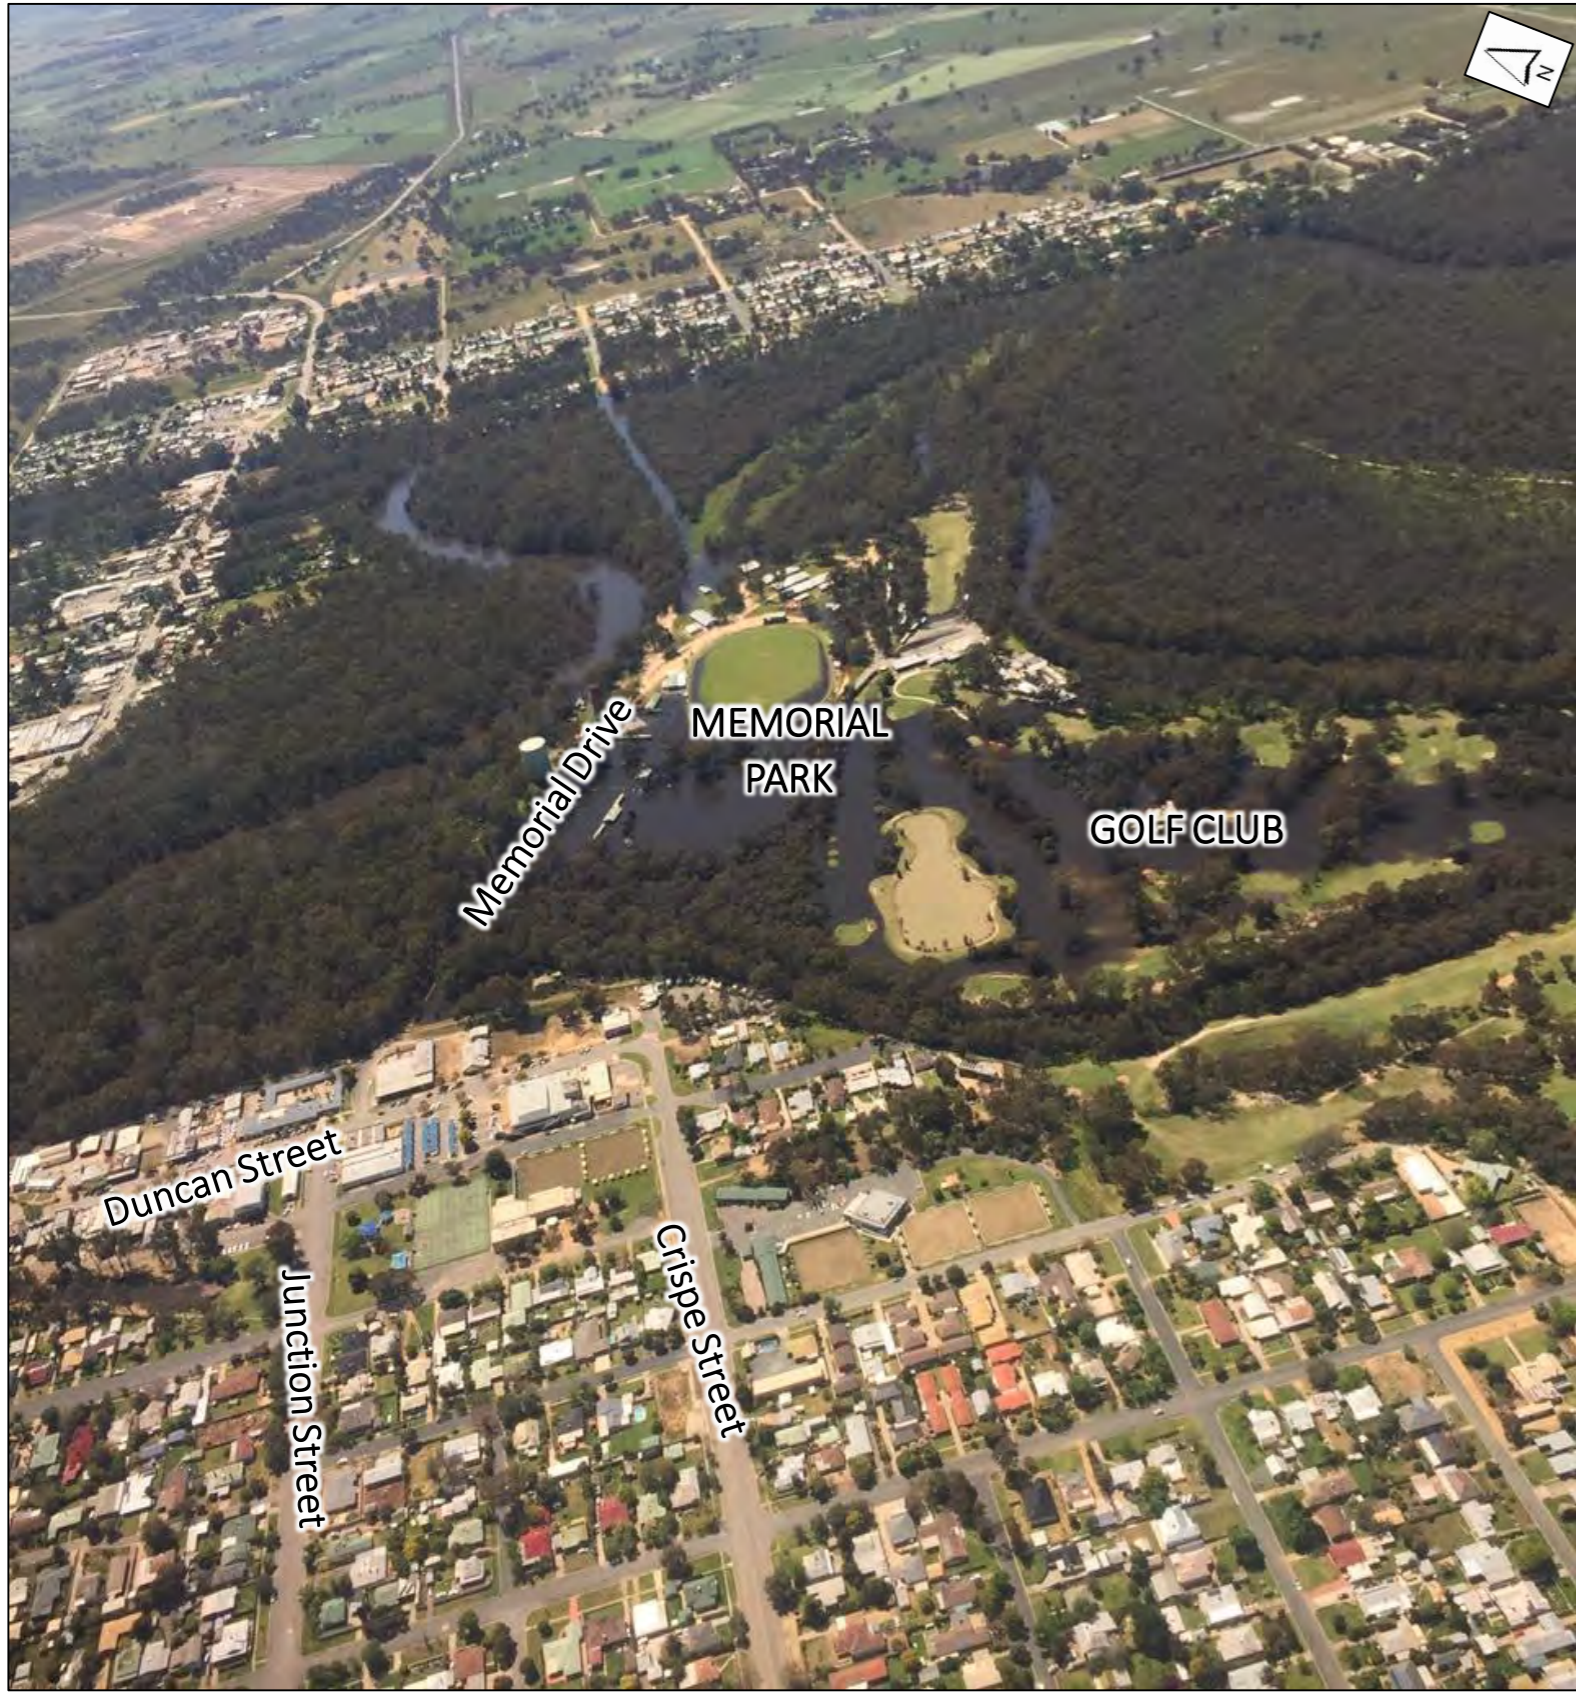
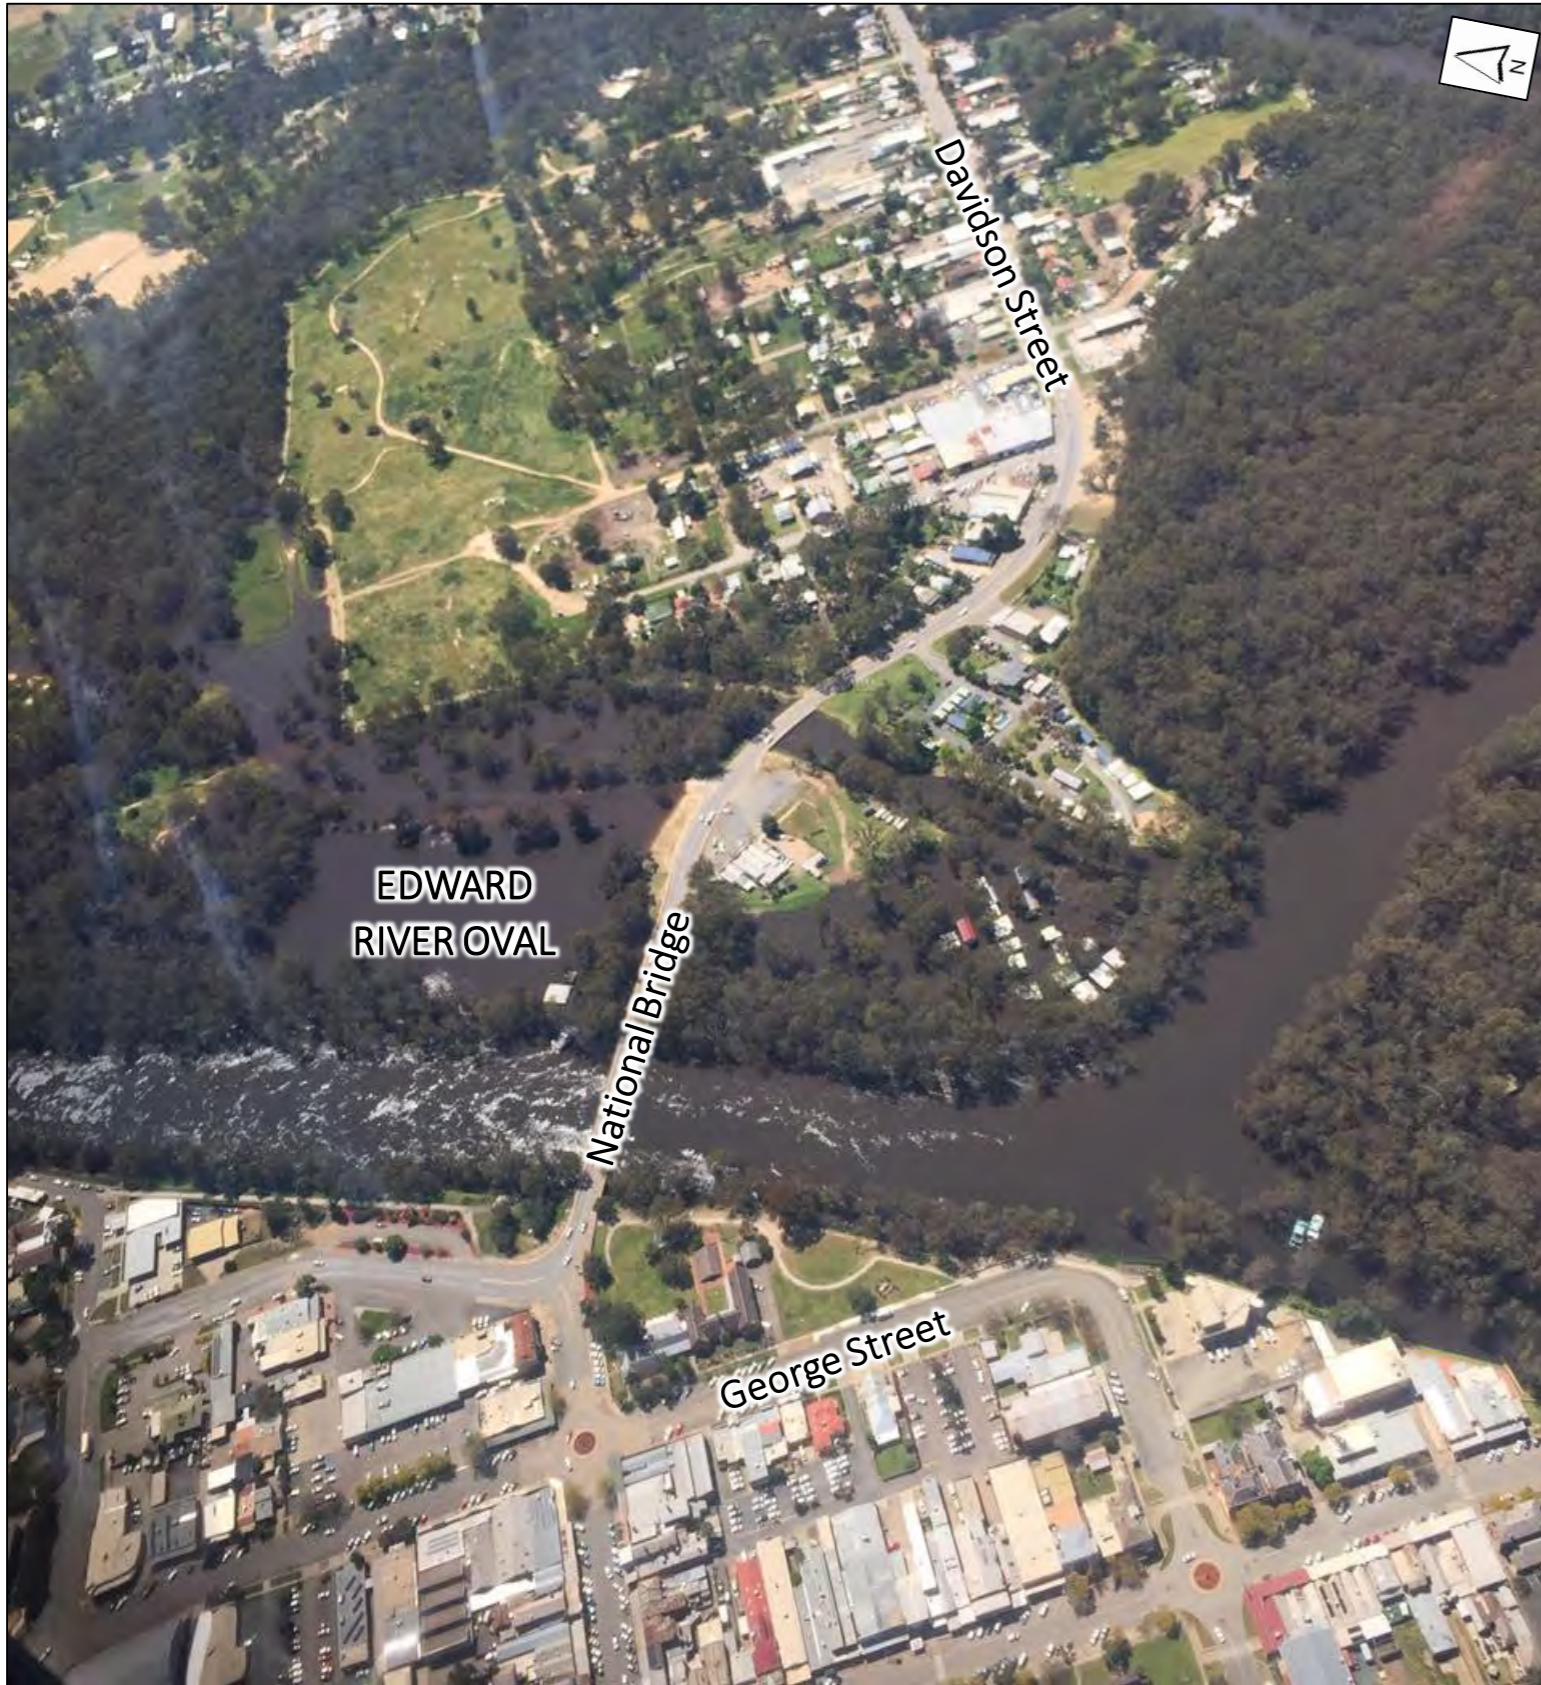
Aerial Image: CAF Consulting 17/10/2016

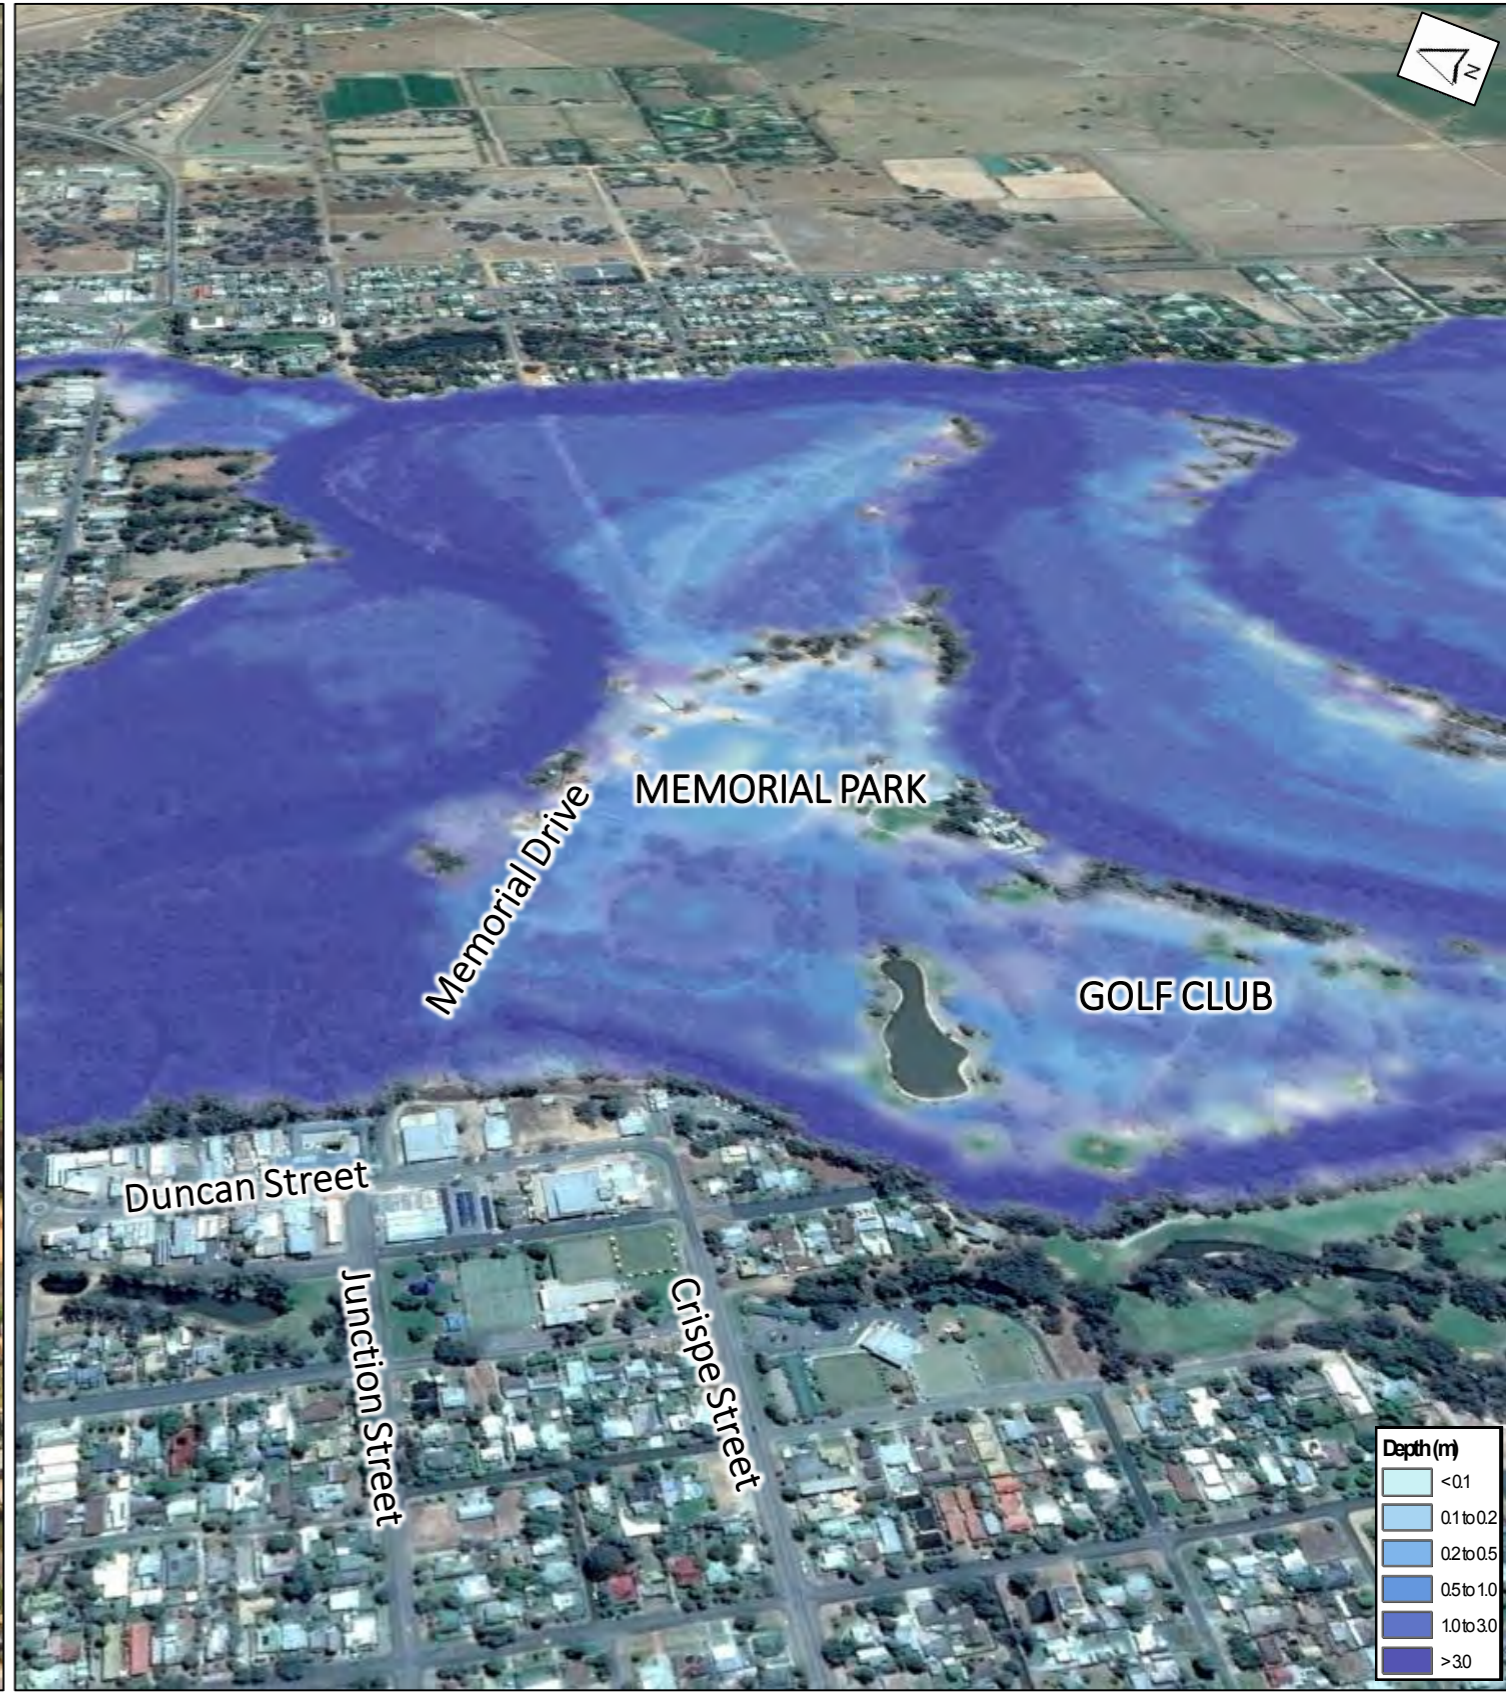
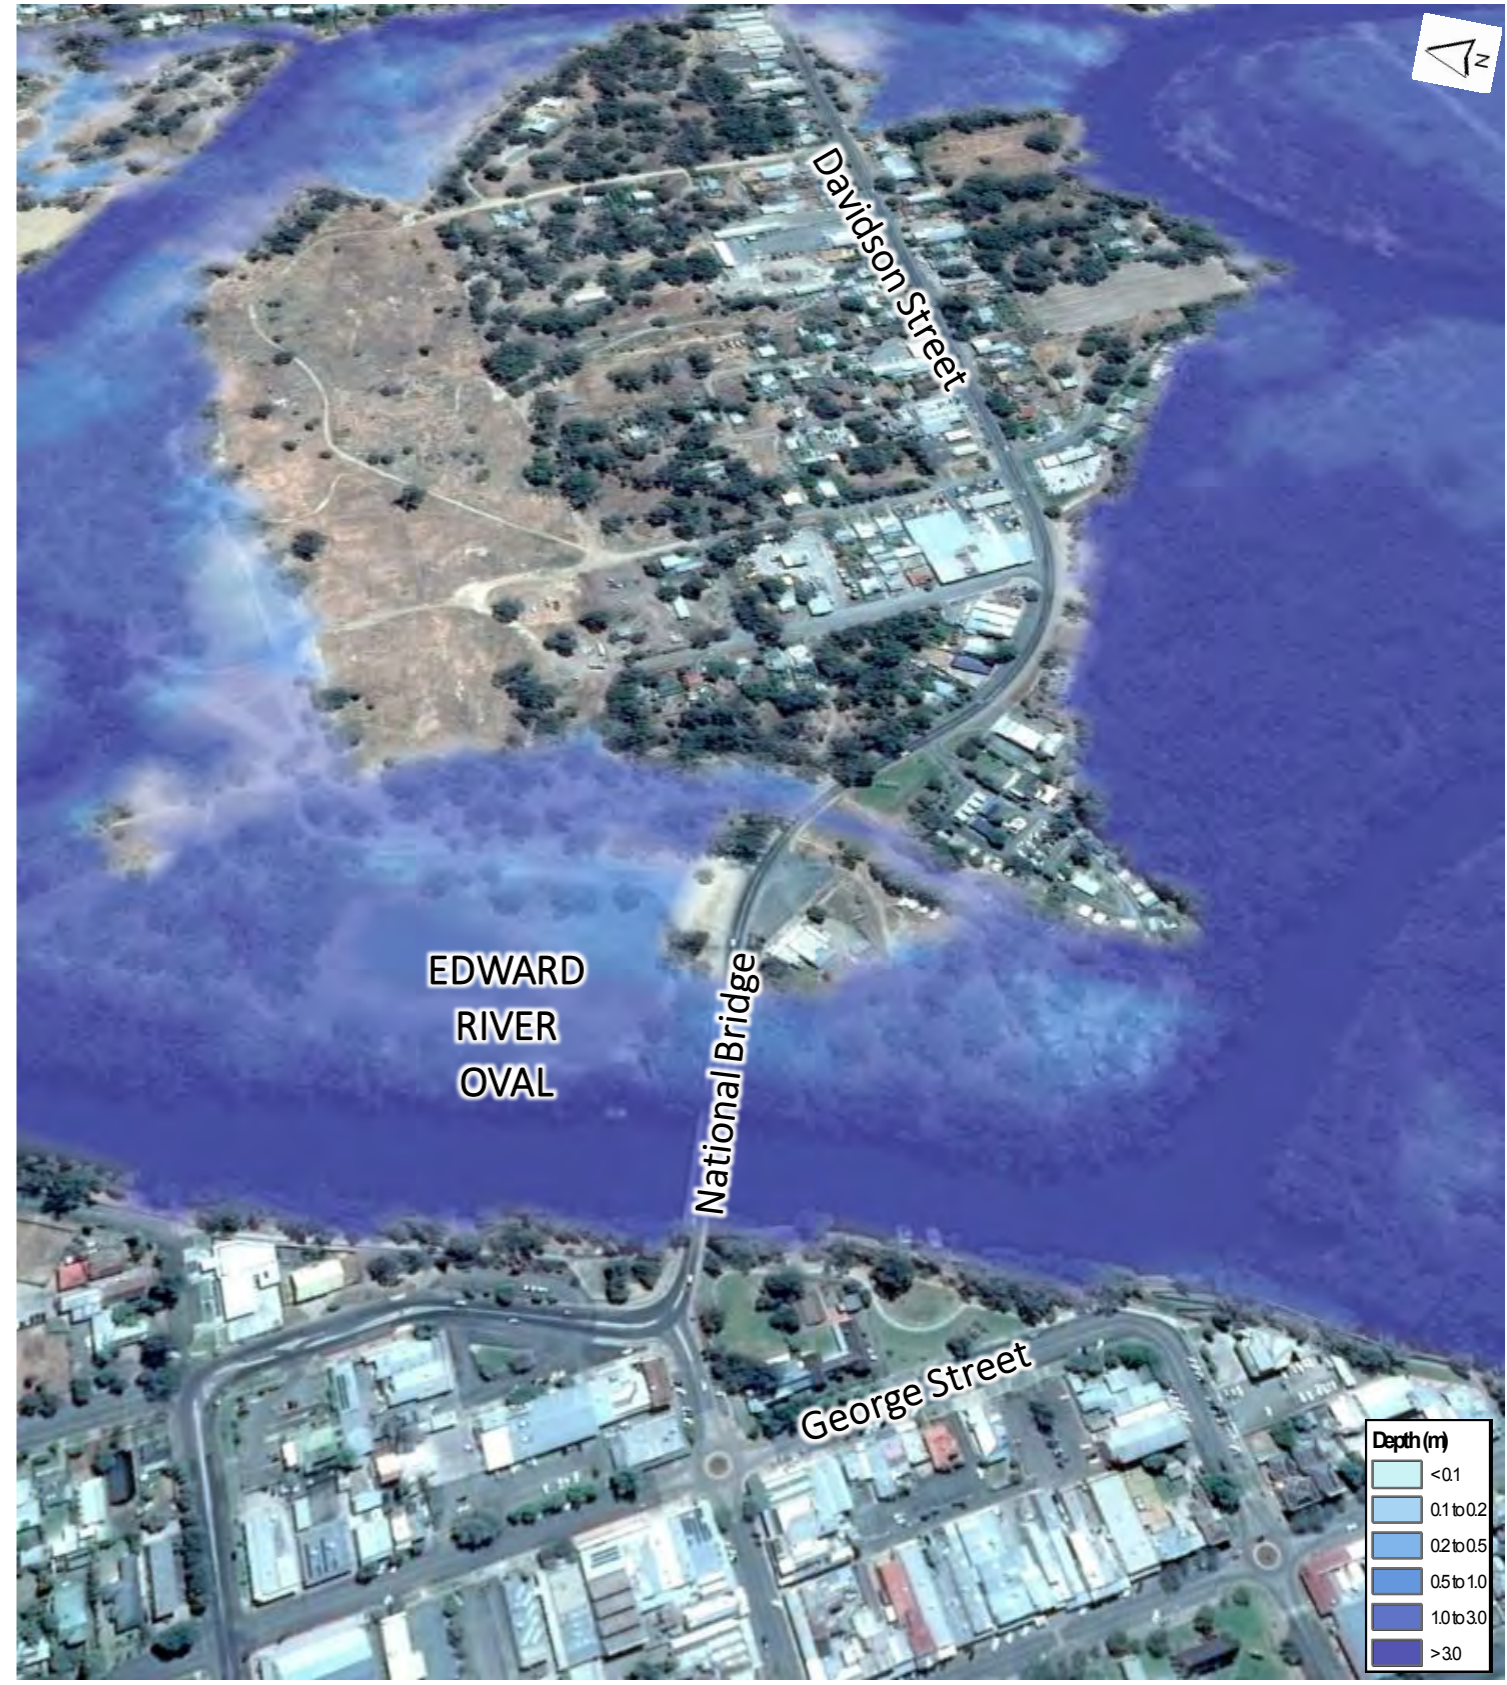
WMA Depth Model for 2016 Flood Event
